FLUVIAL GEOMORPHOLOGY

7.0 FLUVIAL GEOMORPHOLOGY

Etobicoke and Mimico Creeks Watersheds Technical Update Report

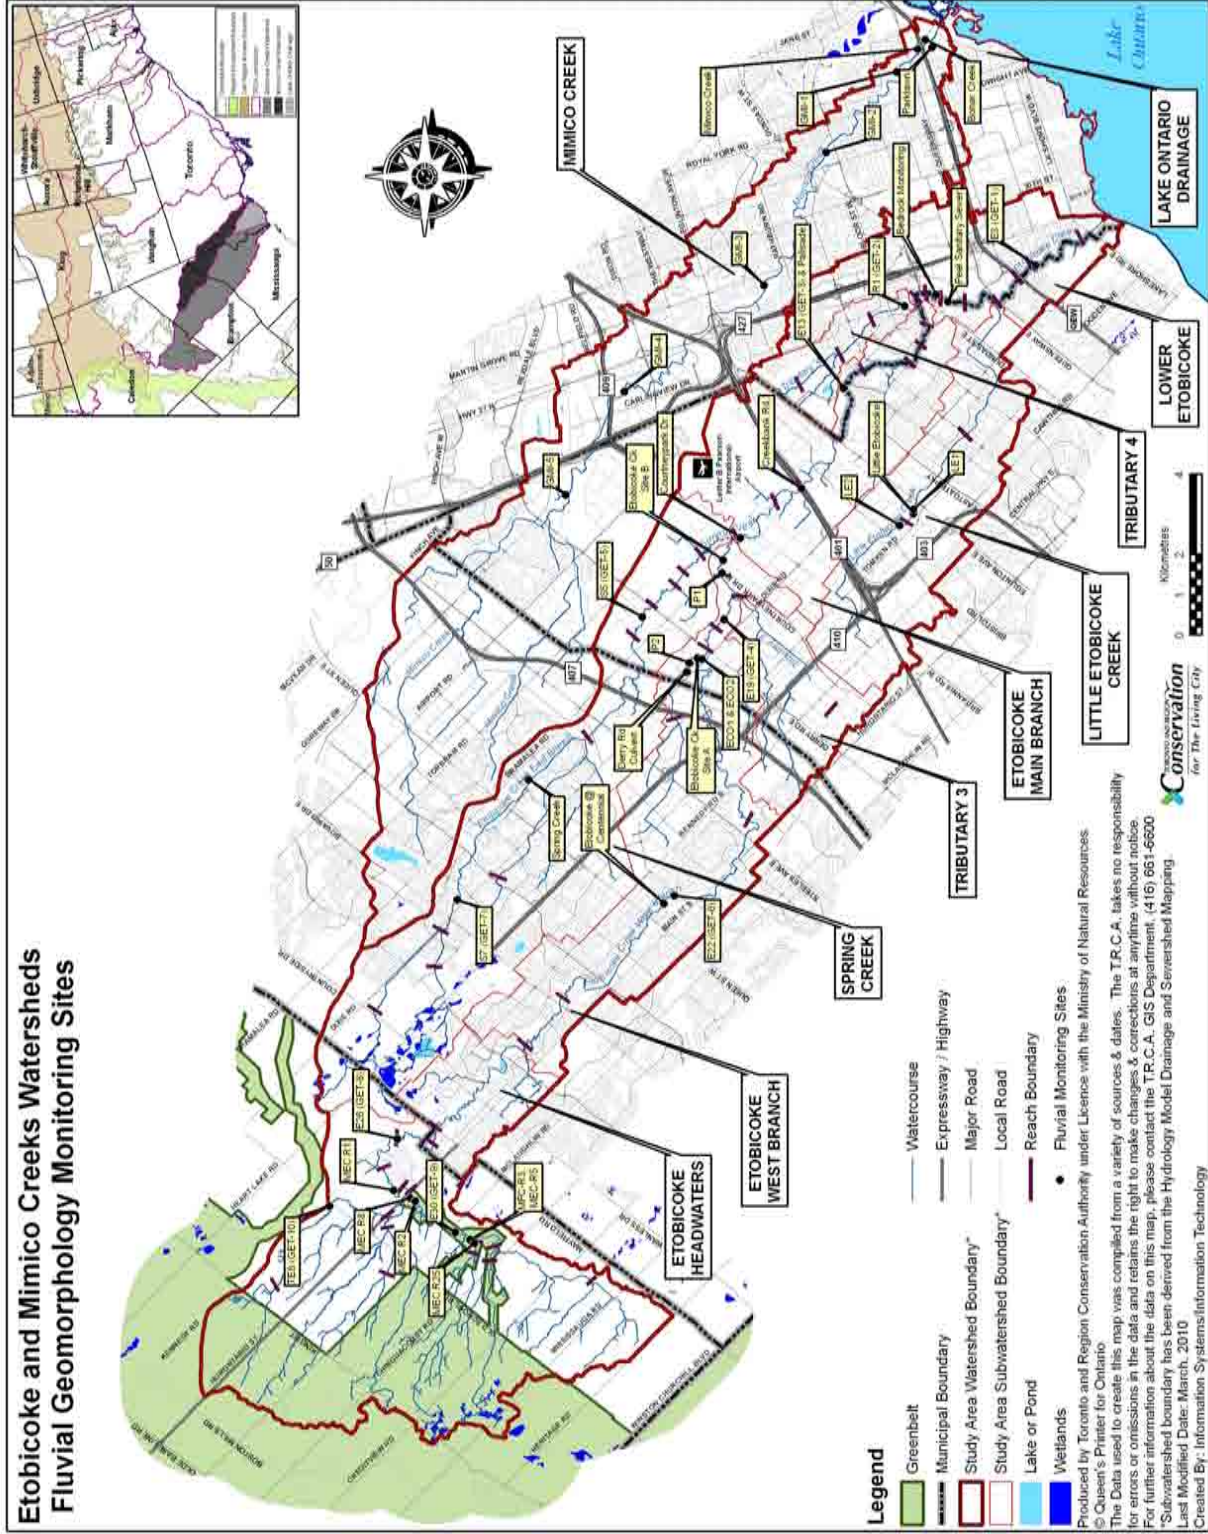
Figure 7-1: Fluvial Geomorphology Monitoring Sites

In 2008, TRCA hired Parish Geomorphic Limited to review and analyze the available TRCA RWMP geomorphic data. As part of the Parish Geomorphic Ltd. study, the TRCA geomorphic data set was augmented with data from an additional 20 field sites. This data was collected under private contracts held between Parish Geomorphic Limited and numerous partners including municipalities, regions and regulatory agencies. The scope of data collected at the Parish Geomorphic Limited sites was dependent on the nature of the project for which the monitoring work was initiated, such that the level of detail and suite of parameters for each of the Parish Geomorphic Limited sites may not be identical to what was collected at the TRCA's RWMP sites. For this reason, not all sites provided useful data for all analyses (Parish, 2009). **Figure 7-1** illustrates the compilation of monitoring sites used.

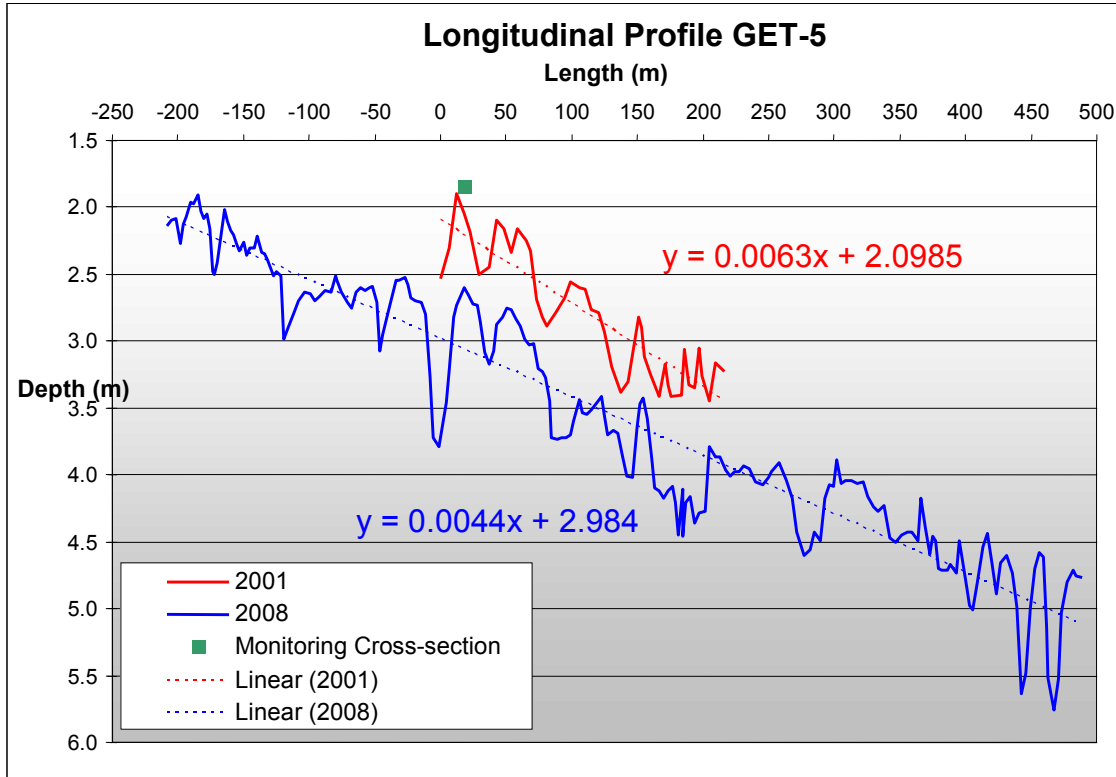
Figure 7-2: Longitudinal Profile Comparison of Bankfull Gradient for Site GET-5, Spring Creek

As previously mentioned, the 2008 Parish study included a detailed field component at three sites, GET-5 in Spring Creek, GET-6 in Etobicoke West Branch and GET-10 in Etobicoke Headwaters, where the greatest degree of erosion was observed. One of the components of the detailed field work was to reassess the bankfull channel gradient at the three sites. **Figure 7-2**, **Figure 7-3** and **Figure 7-4** illustrate the 2002 and 2008 longitudinal profiles for each site and show that the bankfull gradient at each location has remained relatively consistent over the last six years. Other observations show that bankfull gradient is steepest within GET-10, which is typical of headwater reaches, while slopes are the most moderate within the mid-watershed site of GET-6. GET-5 is located on Spring Creek, a tributary to Etobicoke Creek, which has a smaller drainage area and steeper gradient.

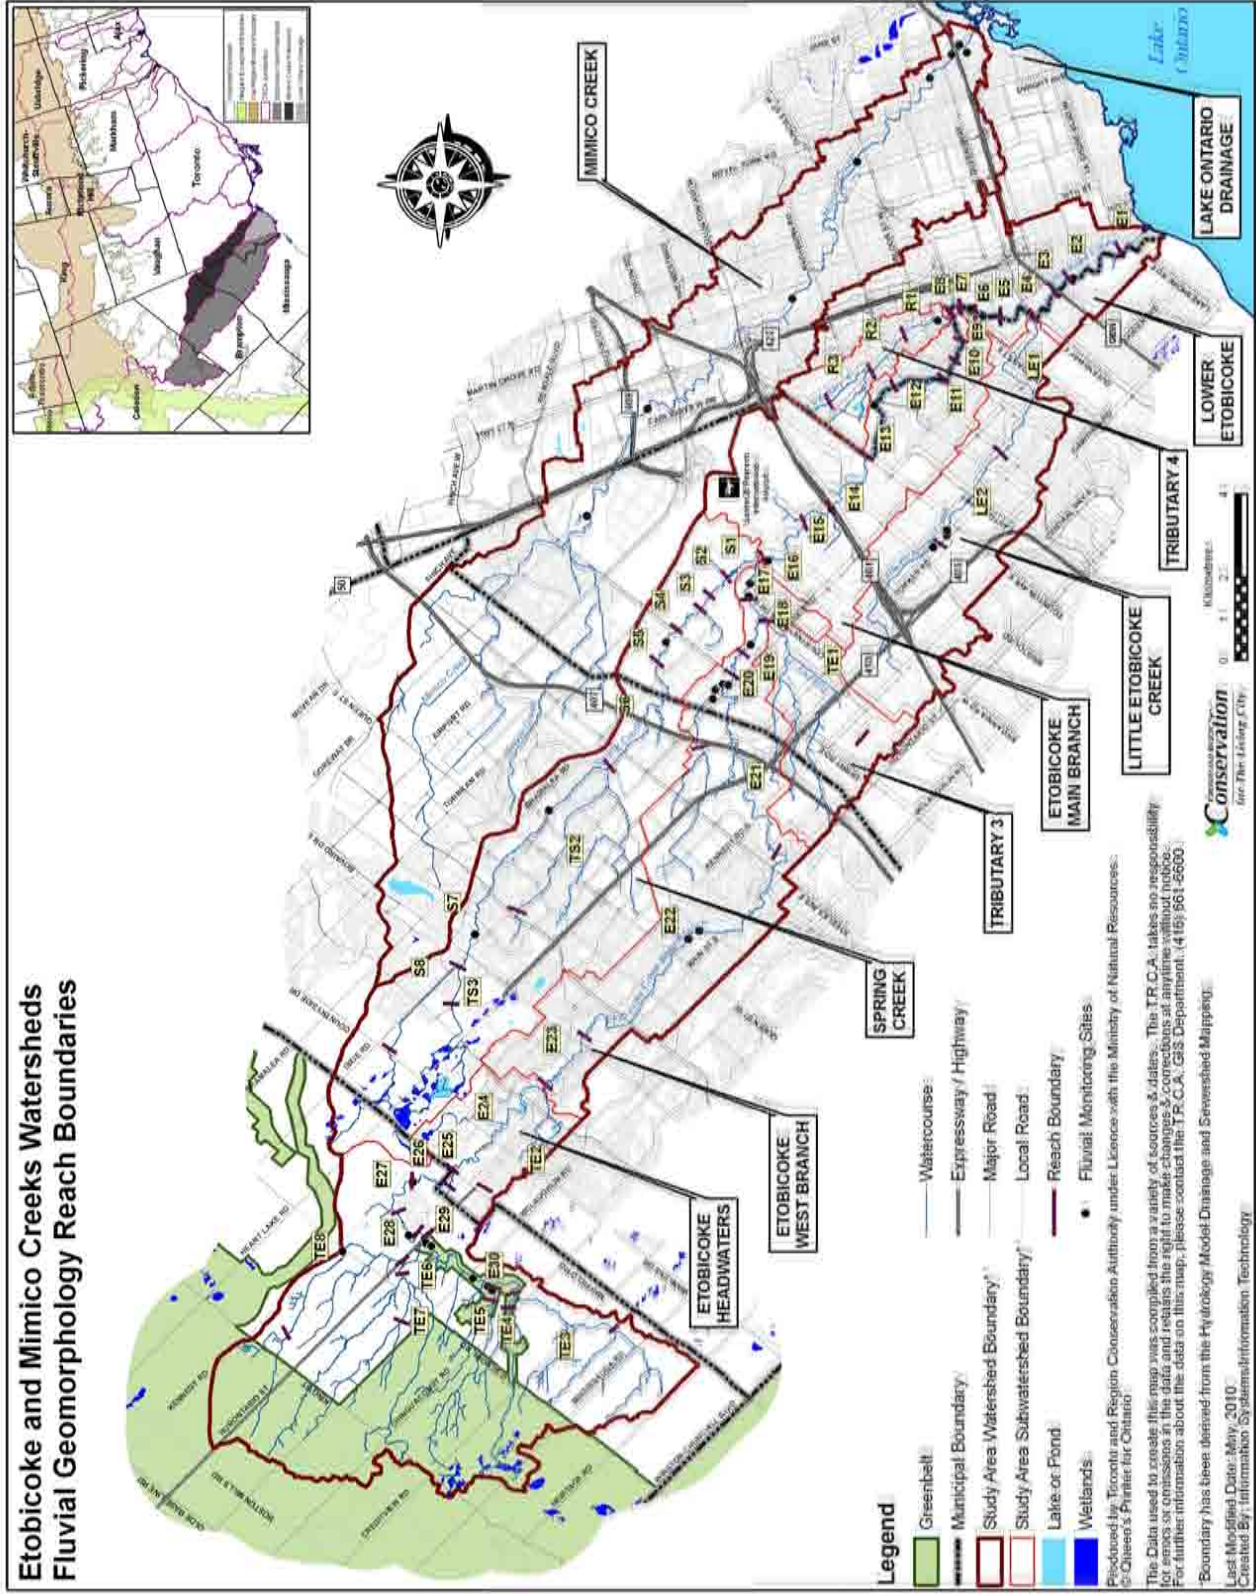
Figure 7-5: Reaches Rated for Erosion Sensitivity

In the Etobicoke Creek, a total of 18 erosion hazard sites have been identified where it is deemed that infrastructure or property would be at risk (see maps in Section 11.4). Additional insights into erosion processes underway at the reach scale are available from the 2005 Fluvial Geomorphic Study of the Etobicoke Creek (Parish Geomorphic Ltd., 2005). That study included a cursory field assessment of potential erosion-prone reaches in the Etobicoke Creek watershed. Observations from the assessment were used to determine an erosion sensitivity rating for each of the reaches. As outlined in **Table 7-10** and shown in **Figure 7-5**, a total of 33

reaches were rated from low to high sensitivity. Of the 33 reaches observed, 18 were noted as moderately sensitive, 12 were noted as highly sensitive and two sites received a combination, moderate/high rating. Only one site was noted as having low sensitivity which was due to the fact that this portion of the watercourse had been previously channelized. Eight of the 18 erosion hazard sites identified under TRCA's Erosion Control Program lie in reaches classified as moderately or moderately/highly sensitive to erosion, while the other sites were in reaches that were not rated as part of the Parish study. This reach scale information can be used to guide decisions about remediation priority and areas that may be more vulnerable to erosion risks and worthy of regular monitoring.

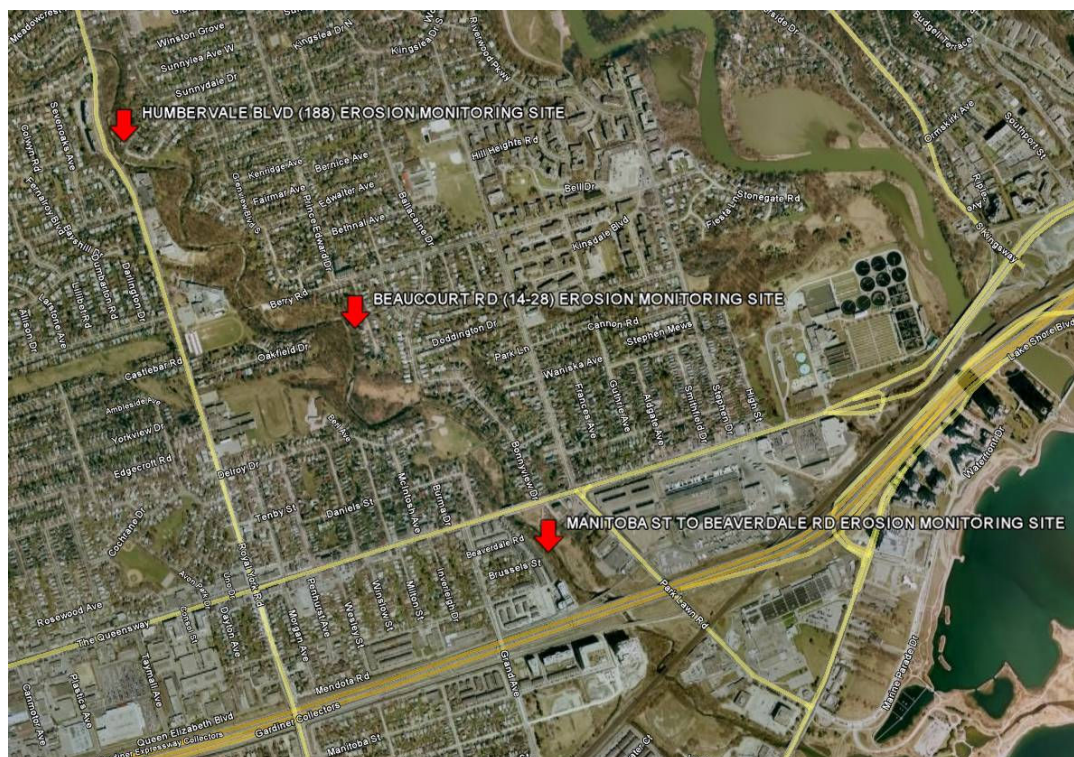
Figure 7-6: Mimico Creek Active Erosion Hazard Sites

There are three erosion hazard sites identified on Mimico Creek, which are presented on **Figure 7-6** and include: Manitoba Street to Beaverdale Road, Humbervale Boulevard and Beaucourt Road. The Beaucourt Road site is situated in the same location as monitoring station GMI1. As per the results of the cross-sectional analysis, described earlier in this section, this is the only location within Mimico Creek that exhibited greater than 5 % change in cross-sectional area.

An understanding of the evolution of channel form provides an important context for management of risk to public and private property associated with channel erosion. Eighteen erosion hazard sites have been identified on Etobicoke Creek where infrastructure or property would be at risk if erosion is left to continue. Three erosion hazard sites are identified on Mimico Creek, in the lower reaches.

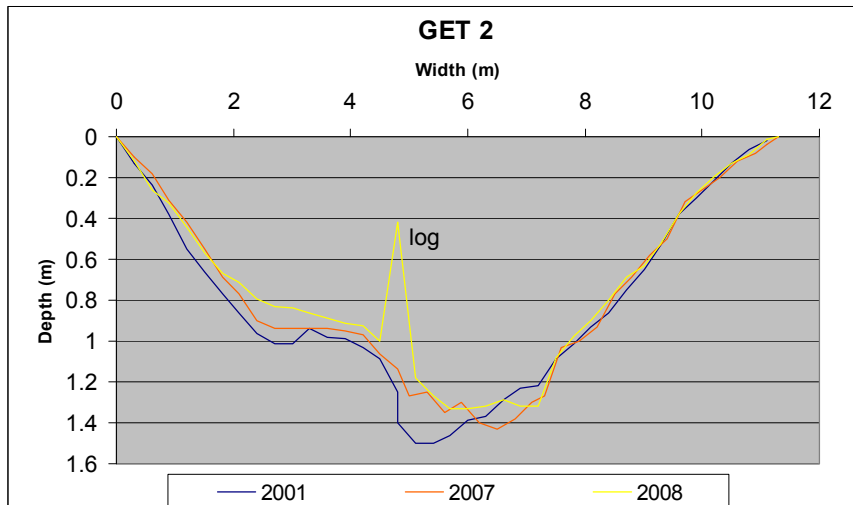
Monitoring Cross-Sections (Etobicoke Creek)

Table 7-6 provides a summary of the cross-sectional area analysis, while graphical representation of the data itself can be found in **Appendix 7-C**. An increase in cross-sectional area (i.e., erosion) is shown as a positive value, while a decrease in cross-sectional area (i.e., deposition) is shown as a negative value.

EC01 situated in Lower Etobicoke illustrates the greatest change of all sites. This site, however, was specifically established as a bedrock monitoring site, together with EC02 in the Lower Etobicoke Creek, within a section of channel identified as sensitive to change. With this in mind, this site might not necessarily be considered representative of conditions within that reach. Also, the sites were established roughly 40 m apart, with EC01 indicating active erosion and the site EC02 indicating deposition. Consequently, the overall trend between these two reaches is still towards erosion (typical of sediment-starved bedrock systems), but with an average change of only 10.4 %.

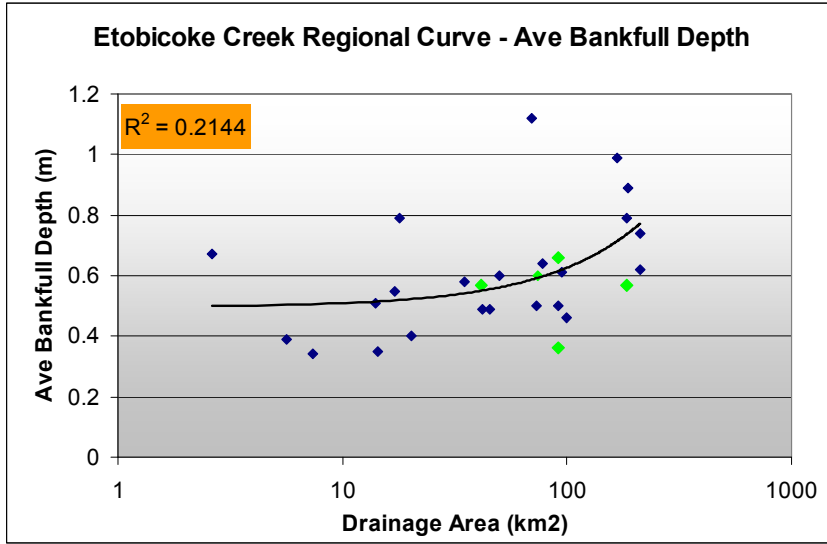
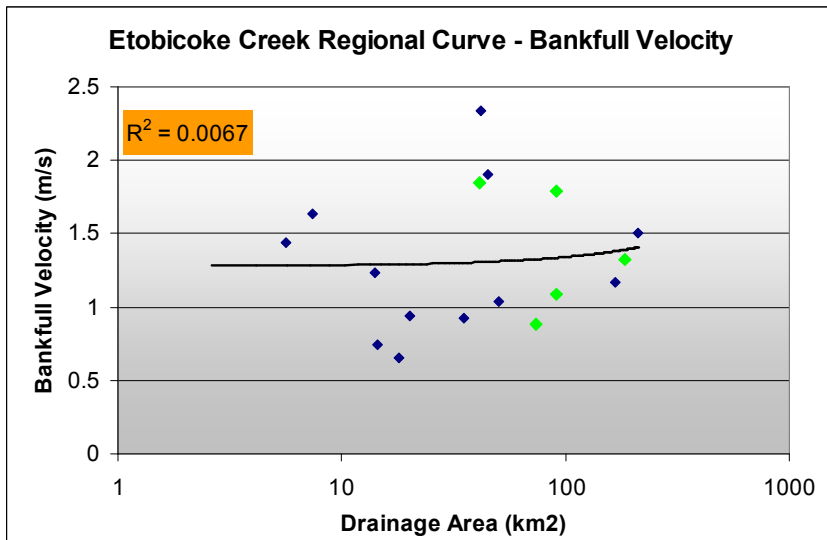
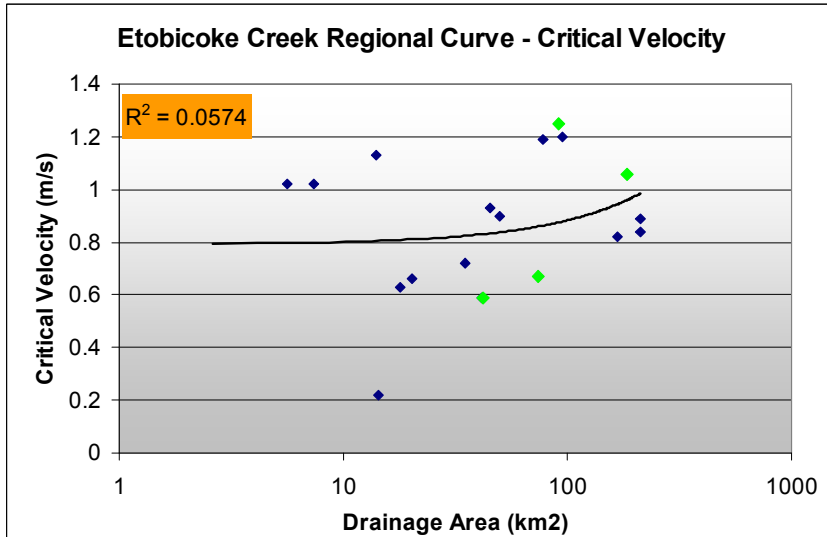
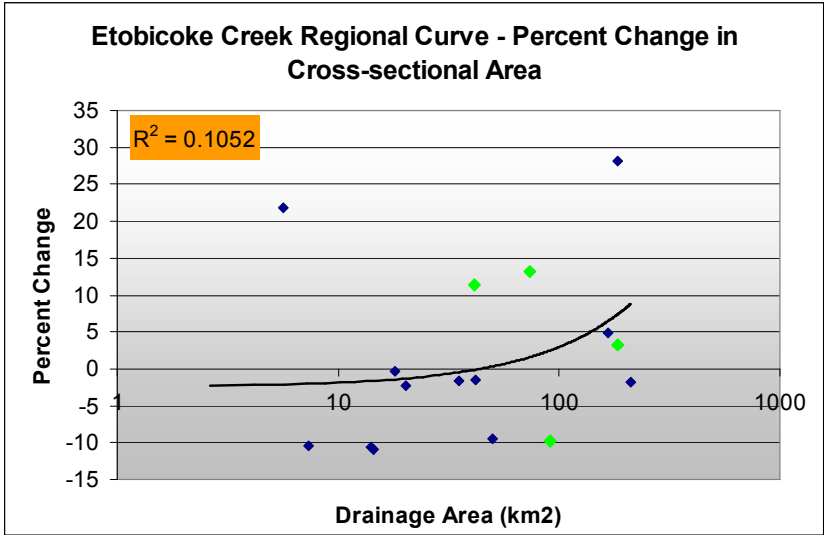
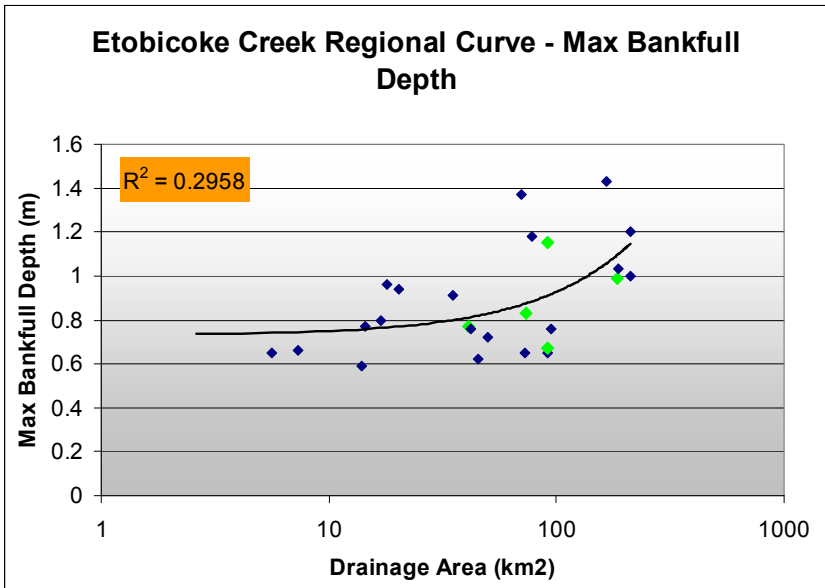
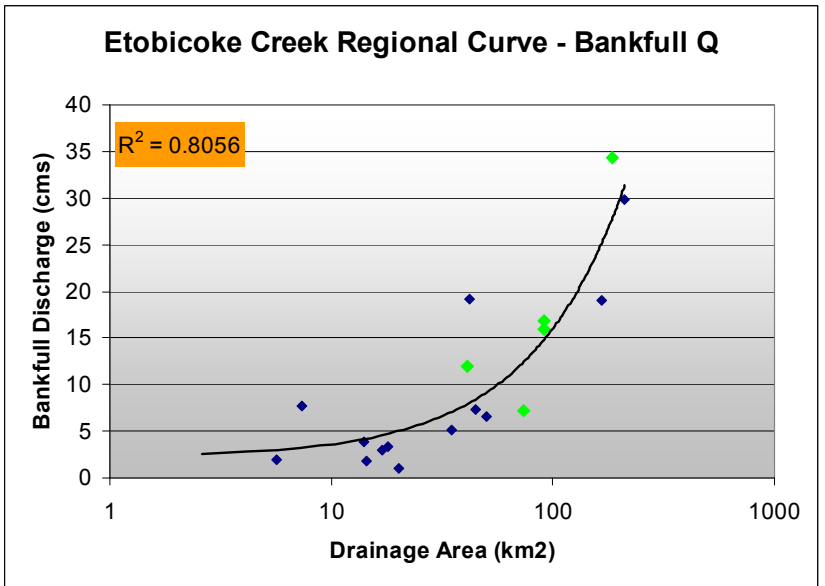
Etobicoke Creek – Regional Curves

Appendix 7- D presents the regional curve results for the Etobicoke Creek watershed. For each of the data plots, a trend line and r-squared value have been presented to indicate the strength of the relationship shown. From a geomorphic perspective, Etobicoke Creek presents several challenges with respect to establishing strong regional relationships in that the data available through various PARISH sources stems from differing land uses, geology and hydrologic regimes. As such, the data set does not meet the key assumptions noted above that provide the basis of the regional curve approach. That being said, one would be hard-
